MAJOR REPAIR AND ALTERATION (Airframe, Powerplant, Propeller, or Appliance)

N1728V

Serial #13913

This Form 337 seeks field approval of the use of engine crankcase mount arm boss adapters to preclude the requirement to change the aircraft engine mount in an STC approved engine replacement/ upgrade to this aircraft.

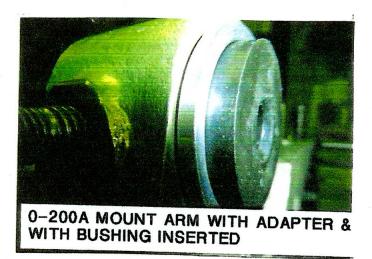
- 3. It is proposed to use four pair of owner produced engine case mount arm boss, machined aluminum, adapters as inserts to reconfigure the 0-200A engine arm bosses to accept the original TCM 22387 conical bushings. (see attachment 1 photo 5). The TCM 22387 bushings are, in fact, approved for and used on other specified 0-200A engines. (see attachment 3). A TCM technical representative ("Ron" @ 1-888-826-5465) researched the 0-200A database and confirmed that certain aircraft manufacturers specified the 0-200 engines with mounting arm boss configurations that used the TCM 22387 conical bushings.

PROPOSED ADAPTER WITH TCM 22387 CONICAL BUSHING

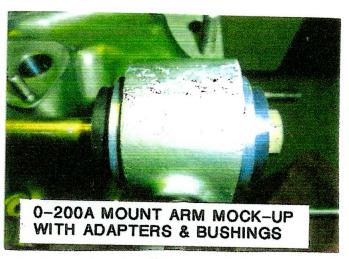
- 5. Each of the identical eight adapters is machined from 5056 aluminum stock. As seen in attachment 1 photo 6, each adapter outside shell has an end flange, a shoulder step, and a straight shank. When inserted into the engine mounting arm end boss, the flange end seats against the outer end of the boss, the shoulder step rests against the boss inner counterbore recess step where the Lord bushing inner washer would normally rest. The adapter outer shank is machined to fit inside the 0-200A arm boss. (see attachment 5 photo 1). The inner bore of the adapter is machined to accept the TCM 22387 conical bushing with a close fit. (see attachment 5 photo 2 and 3). When installed, the compression load, due to engine mount bolt torque, on the TCM 22387 bushing causes it to swell to a tight fit inside the adapter. (see attachment 5 photo 4 for a loose-fit mock-up of the proposed configuration on an 0-200A engine arm).
