Breather Modification

For the Continental C-85, C-90 and the O-200 engines

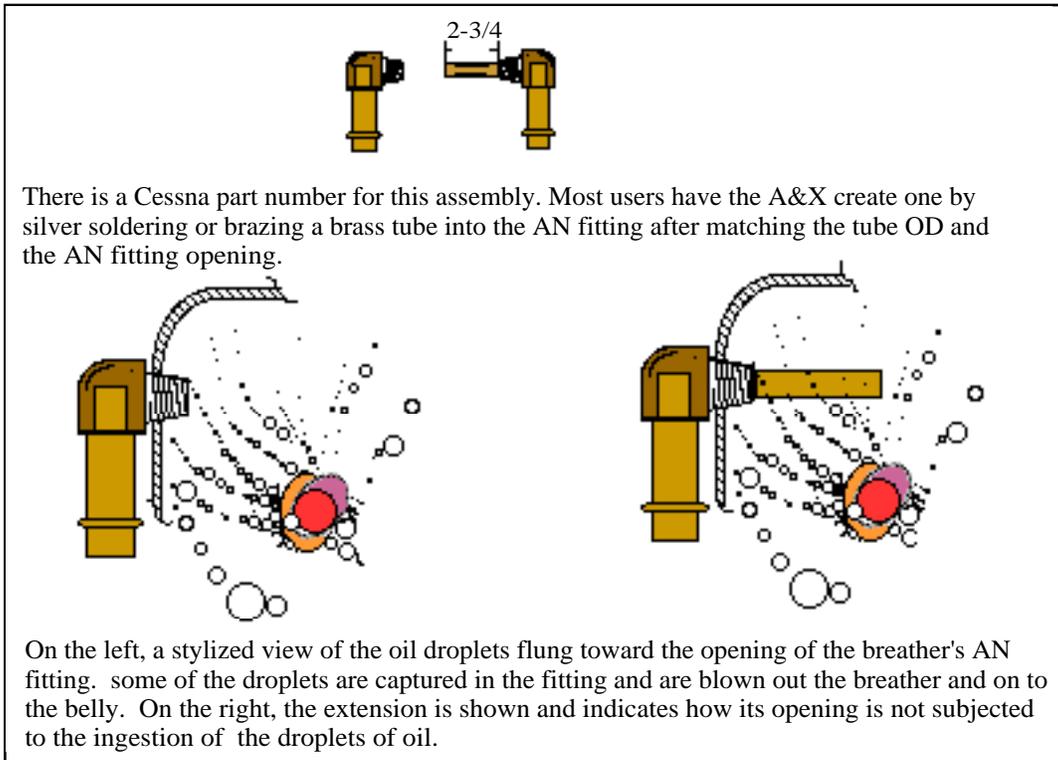
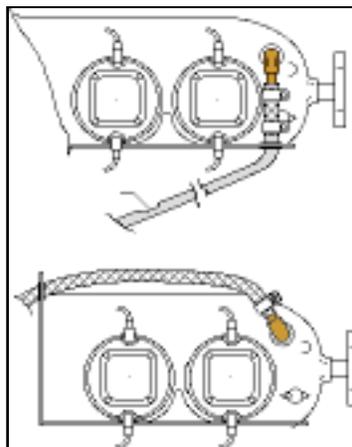
Continental's cure for breather oil loss is to modify the AN 842-10 breather fitting about as shown. The part may be used on any of the C-85/C-90 or O-200 engines.

The sketches tell the story. The tube is copper or brass or steel (steel per the sketch I got from the Continental rep), with its OD machined to fit inside the bored out portion of the AN 842-10. The difference in OD of the pipe and the ID of the fitting should match the process used to join them...about five thousandths for brazing. Brazing is known to be compatible with the other materials of the engine.

This part is available from Continental under a special part number, but is found in few of their parts lists. Add the brass tube and secure by brazing or silver soldering.

The Continental assembly (the two pieces joined) number is **633182**, but the Continental rep could not find it in the parts catalog. It is made up of the usual AN 842-10 fitting and the new tube; the new tube's part number is 633250 but it isn't in the parts catalog either. It is recommended that you have one made and sanctioned by the A&I versus buying it from Continental because the price was thought to be outrageous even by the Continental rep who got the information for me.

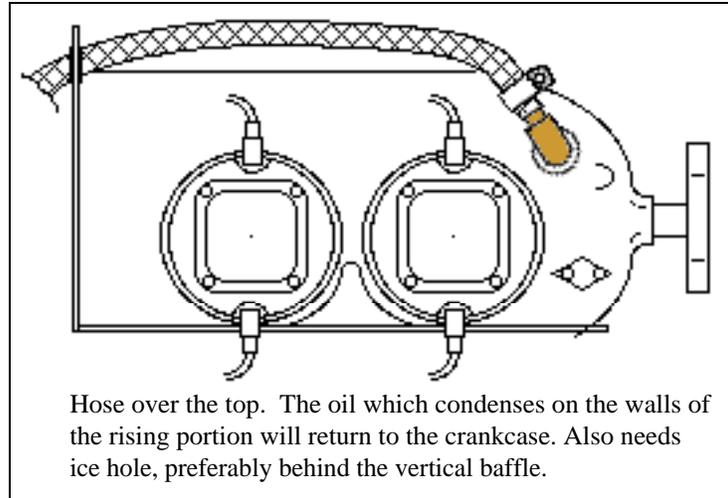
The next figure shows the “over the top” method using a hose as so often mentioned. This can be combined with the extended part. In the first figure based on the usual breather tube, I showed the recommended “ice hole” in the tube which is meant to allow bypass of the crankcase pressure in the event the end of the breather tube becomes plugged with ice. The combustion process creates water, part of which enters the crankcase by way of ring blowby. If the end of the breather tube is subjected to freezing air, an ice plug can form, leading to oil loss via the prop seal. The ice hole in the metal tube is usually at the point nearest the hottest exhaust item it passes (easy for 150 mufflers). The over the top hose should have an ice hole, too, and the best? place for it is behind the vertical baffling.

With the extension and the hose, two things combine to reduce the amount of oil loss; when the droplets impact something such as the 90 degree bend of the elbow or the inside of the tube, they coalesce and stick to the walls and drain back inside the engine.

For those who wonder about such things as the effects of the angle of cut of the breather tube end, which way it faces, where it is positioned relative to the cowl’s bottom lip, whether inside the cowl or outside, whether one exposure will create a vacuum (it can) or an unwanted pressure (it can) and all such things...it seems to work best with a straight or slightly slanted as suggested in the sketch.
